Manhole Inspection Summary

Manhole # S49M__013MH

Insp Date: **4/16/08 2:09 PM**

Location Address: **2500 hudson st**

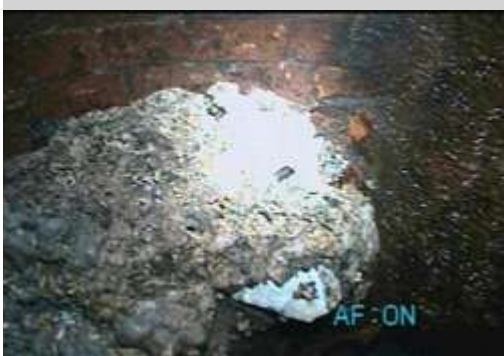
Defect 3

Condition: ☐ Sound ☐ Cracked ☐ Root Intrusion ☐ Deteriorated ☐ Leaks ☒ **Debris**

bench debris

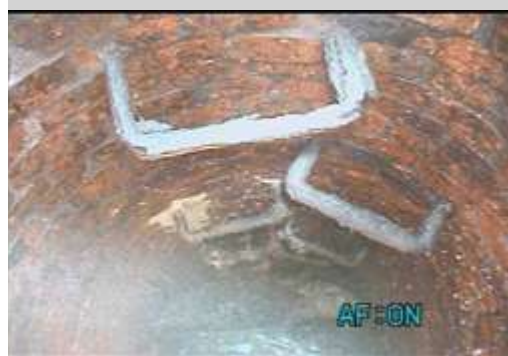
Defect 2

Count: **8** Missing: **0** ☒ **Corroded**

corroded stairs

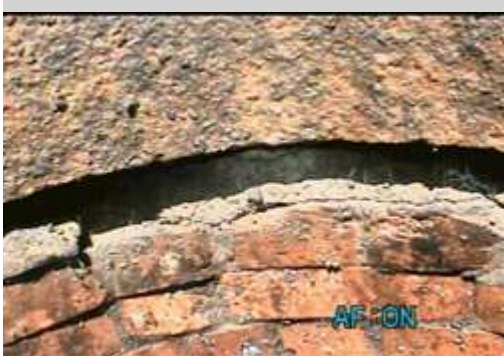
Defect 1

Condition: ☐ Sound ☐ Cracked ☐ Root Intrusion ☒ **Loose Brick** ☐ Deteriorated

loose bricks, frame adjustment

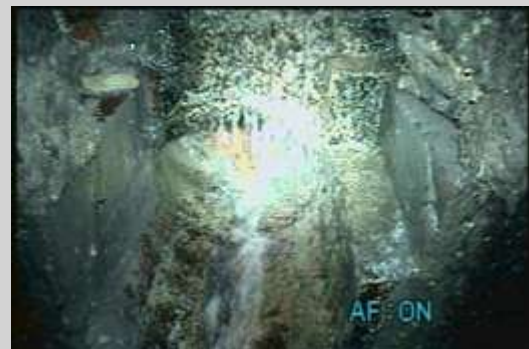
Drop In @ 3 O'Clock

difficult to take because of water coming down

Drop Condition: **Clogged**
